Merits of Double Bottoms in Crude Oil Tankers as Applied to the “Exxon Valdez” Spill of March 24, 1989

Rik van Hemmen, P.E.

June 1992

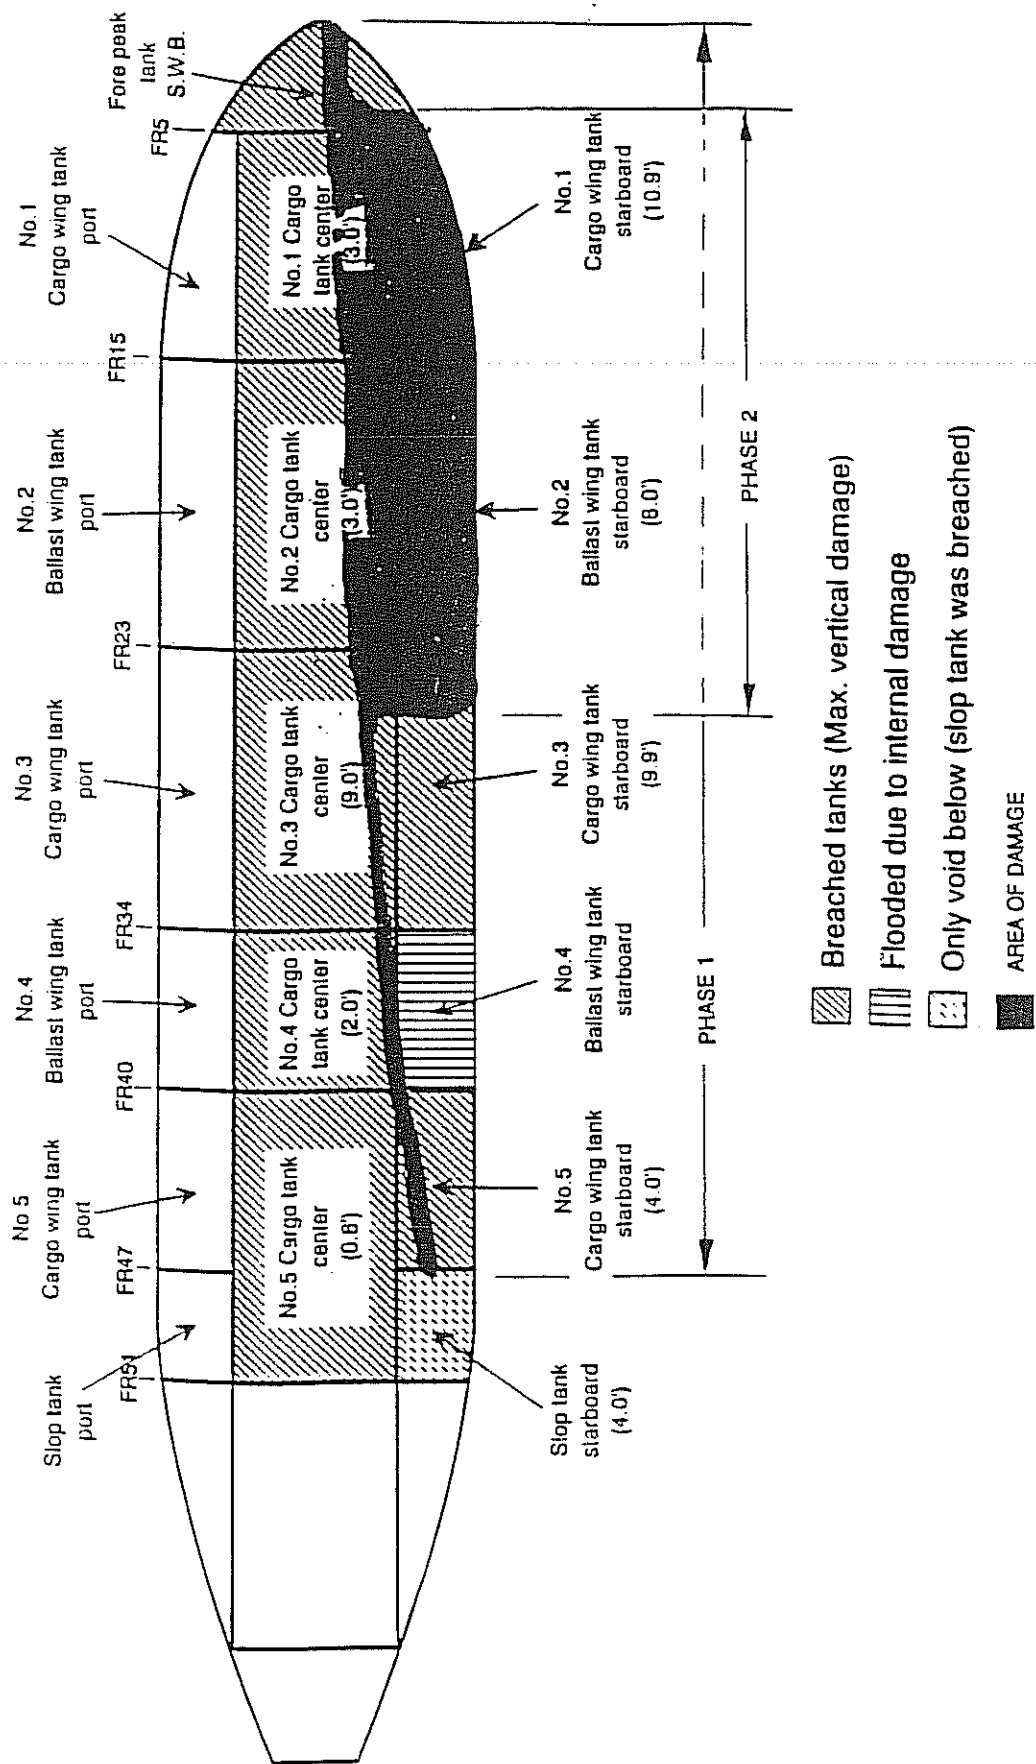
FIGURE 8: PLAN VIEW SHOWING DAMAGED TANKS ON THE MT "EXXON VALDEZ".

Figure 8 is copied from the NTSB study and indicates which cargo tanks were damaged, and shows a rough outline of the damages superimposed on the vessel's plan view. The damage heights noted in the diagram by NTSB apparently do not exactly agree with the damage heights noted in the NTSB written report. We have no explanation for this apparent discrepancy.

The damage to the vessel's bottom has two distinct phases, as shown in figure No. 8.

Examination of the records of the damage reveals that there is a long and relatively narrow and shallow gash which runs almost over the entire length of the vessel from the bow to frame 49 where it leaves the vessel at the starboard turn of the bilge. This gash will be called the "first damage phase".

In all likelihood this gash was caused by a single pinnacle, which quite possibly was located a fair distance from where the vessel came to rest. This pinnacle was solely responsible for the rupture of tanks No. 4C, No. 4S (ballast), No. 5C, No. 5S, and the starboard side slop tank.

The "second damage phase" is the massive damage which extends from the bow to frame 24 in the No. 3 tanks and has the shape of a tunnel, with gradual lessening of the tunnel towards frame 27. It appears that the latter phase is caused by the pinnacle on which the vessel came to rest.

Naturally the "first phase" damage is obliterated by the "second phase" damage up to frame 27, although from the transverse location of the "first phase" damage at frame 27 it would appear that the "first phase" pinnacle alone would have also holed the Nos. 1, 2, and 3 center cargo tanks.

As noted in the various reports, a tunnel about 75 feet wide, with a maximum height of about 8 feet was cut into the bottom of the vessel in way of the "second phase" damage, and a gash approximately 4 feet high and 20 feet wide was cut in way of the "first phase" damage. The frontal areas for these damages are estimated at 300 square feet and 40 feet respectively.

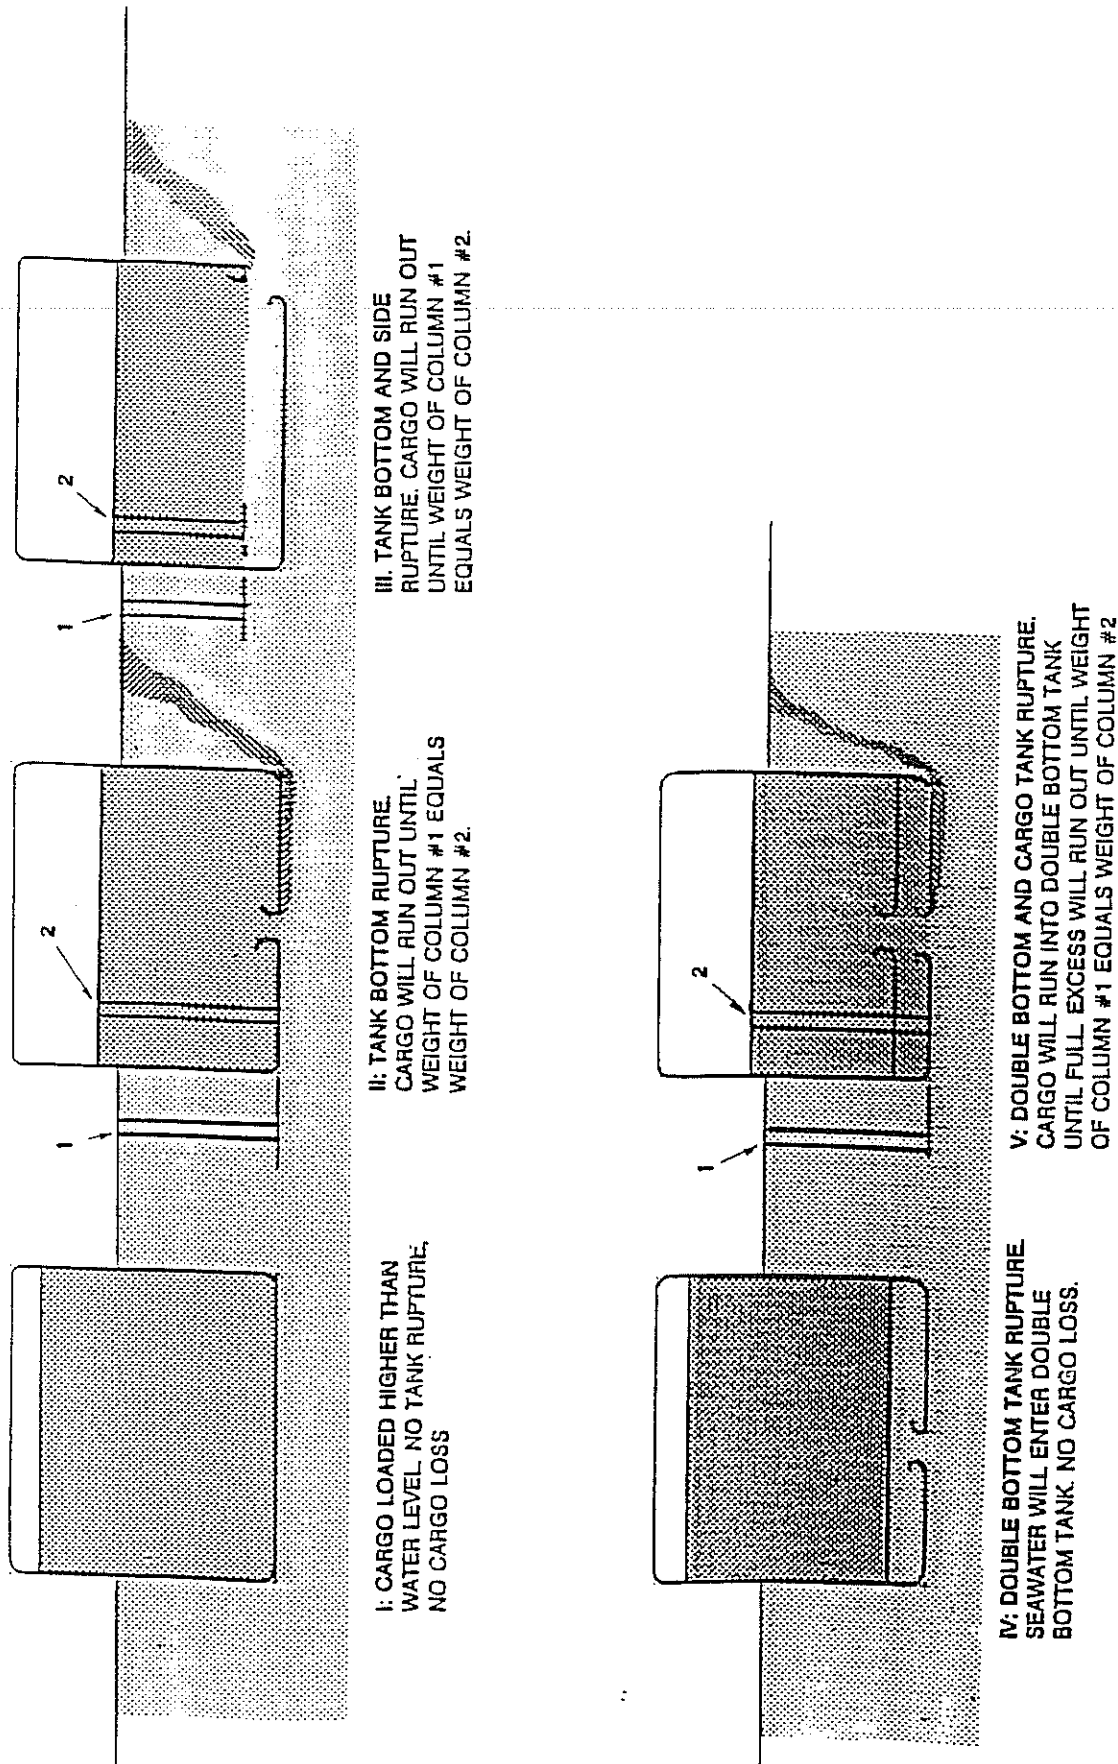
FIGURE 10: EXPLANATION OF CARGO OIL LEVEL IN A GROUNDED TANKER WITH RUPTURED TANKS.

With a hole in the bottom, not all the cargo in a ruptured tank flows out into the sea. From a physical point of view cargo will flow out of the tank until the hydrostatic pressure between the column of oil inside the tank, and the column of water outside the tank has been equalized. Figure 10 illustrates that principle.

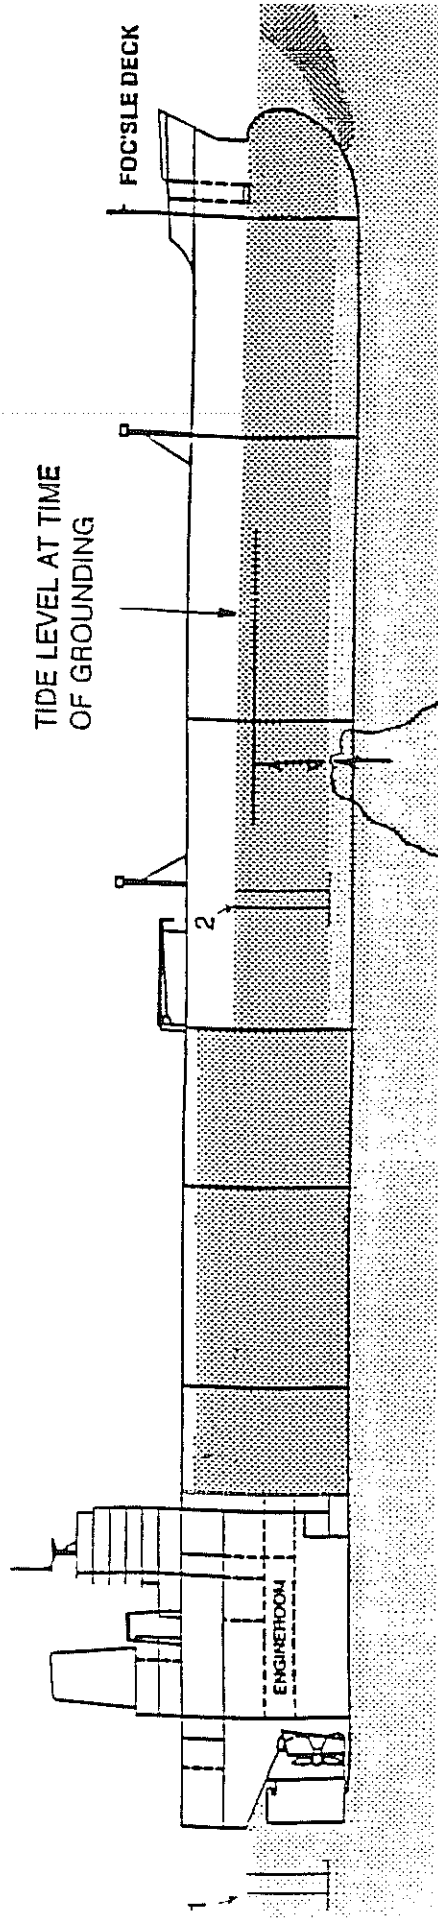
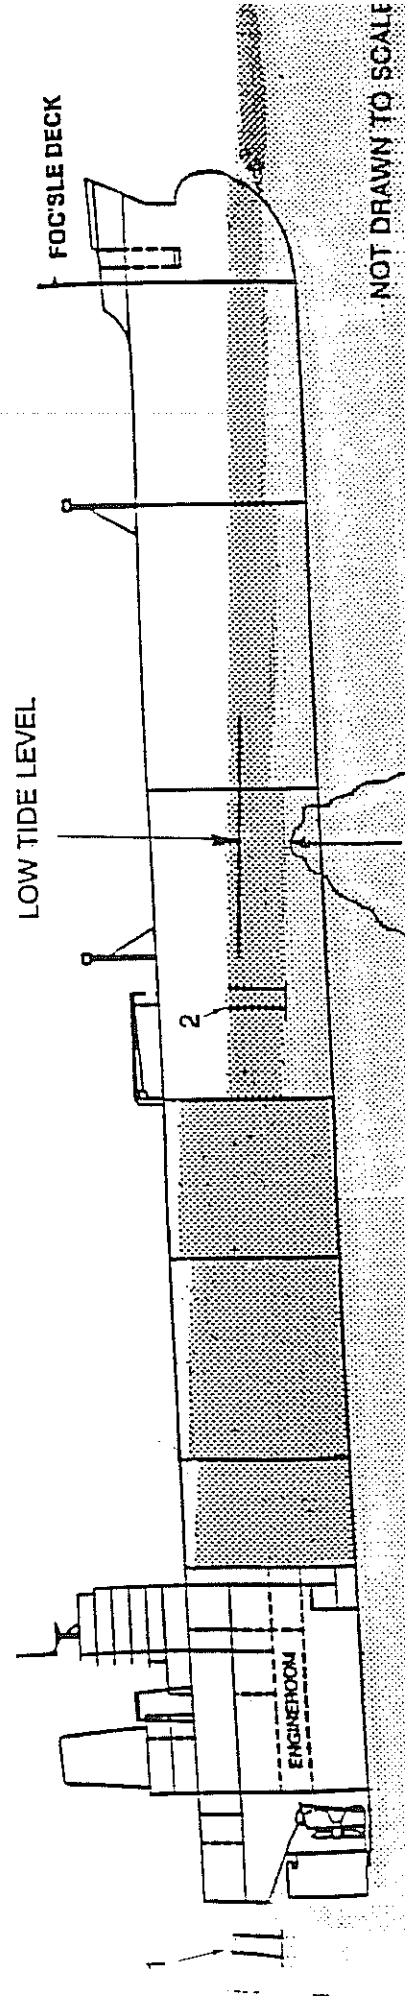
FIGURE 12: EXPLANATION OF CARGO OUTFLOW ON A GROUNDED VESSEL WITH RUPTURED TANKS, AND TRIM BY THE STERN.

This trend can be explained for two reasons. First the vessel probably rotates about the end of the No. 2 tanks (frame 23, where she is hung up on the reef), which with lowering tides causes the stern to settle, thereby keeping the hydrostatic pressure in the aft tanks higher. Secondly, the openings in the forward tanks generally were larger than the openings in the aft tanks, allowing easier mixing and pumping action due to waves.

VESSEL GROUNDS AT EVEN KEEL AND OIL FLOWS OUT UNTIL WEIGHT OF COLUMN #1 EQUALS WEIGHT OF COLUMN #2

TIDE GOES DOWN AND VESSEL TRIMS BY STERN THEREBY RAISING BOW CAUSING ADDITIONAL CARGO TO FLOW OUT UNTIL WEIGHTS OF CARGO COLUMNS EQUALS WEIGHTS OF SEAWATER COLUMNS

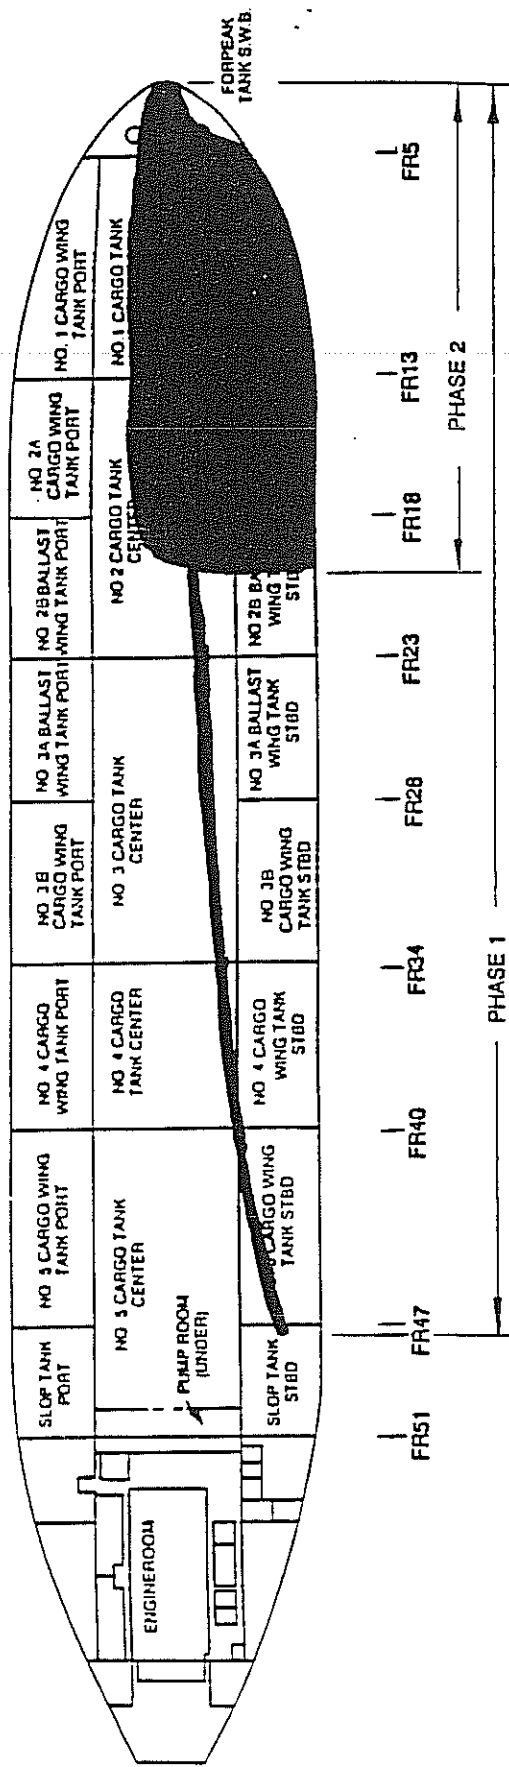
FIGURE 13: PLAN VIEW SHOWING DAMAGED TANKS ON THE 8 FOOT EQUIVALENT DOUBLE BOTTOM TANKER.

Figure 13 shows the arrangement of the 8 foot double bottom equivalent design with the damage superimposed.

It can be seen from this figure that the damaged tanks will be tanks Nos. 1C, 1S, 2C, 2SA and 2SB.
